**CotY**<sup>™</sup> 2012  
Regional winner  
Residential Exterior Under \$100,000

## **EXO VATIONS® 2012 CotY Award Winning Project**

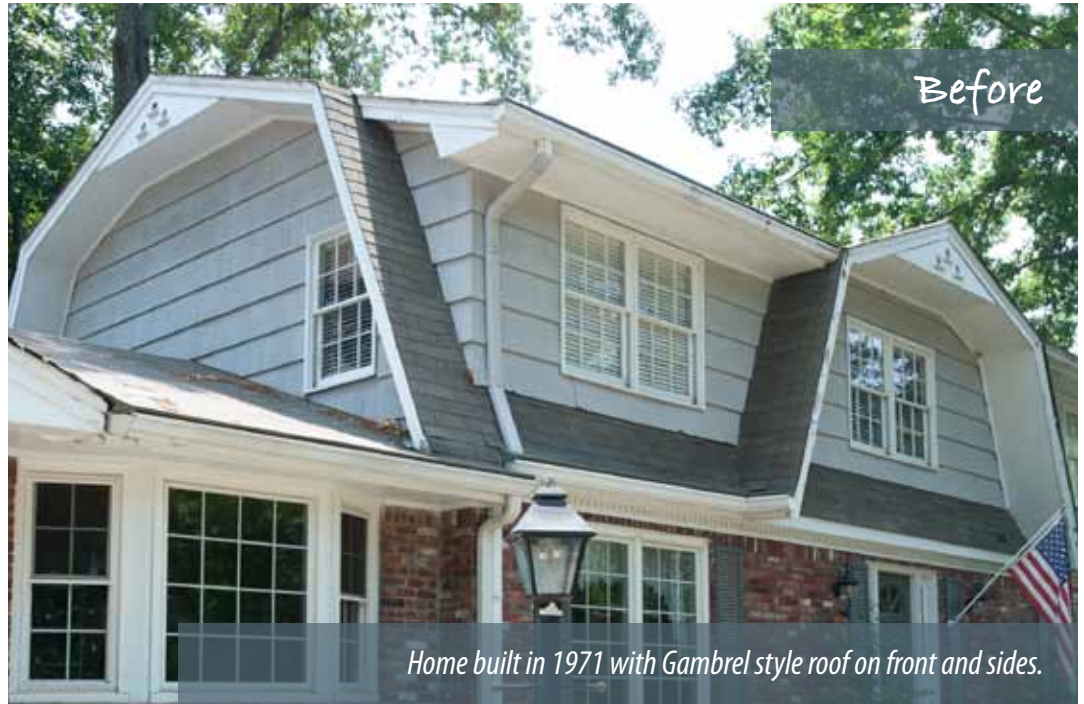
*Home built in 1971 with Gambrel style roof on front and sides.*

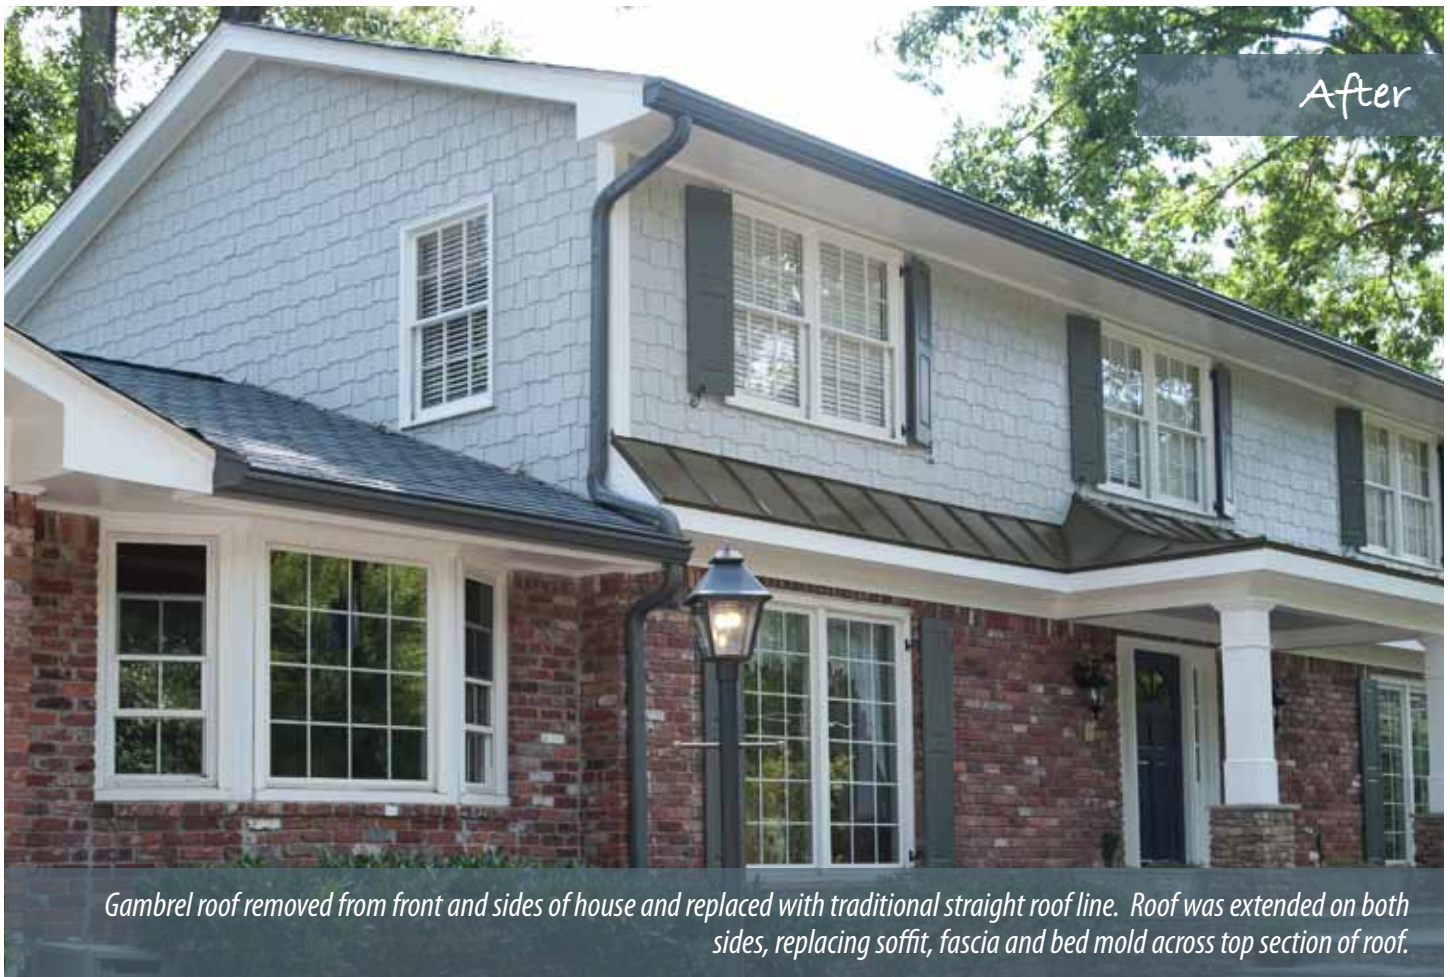
*Gambrel roof removed from front and sides of house and replaced with traditional straight roof line. Roof was extended on both sides, replacing soffit, fascia and bed mold across top section of roof.*

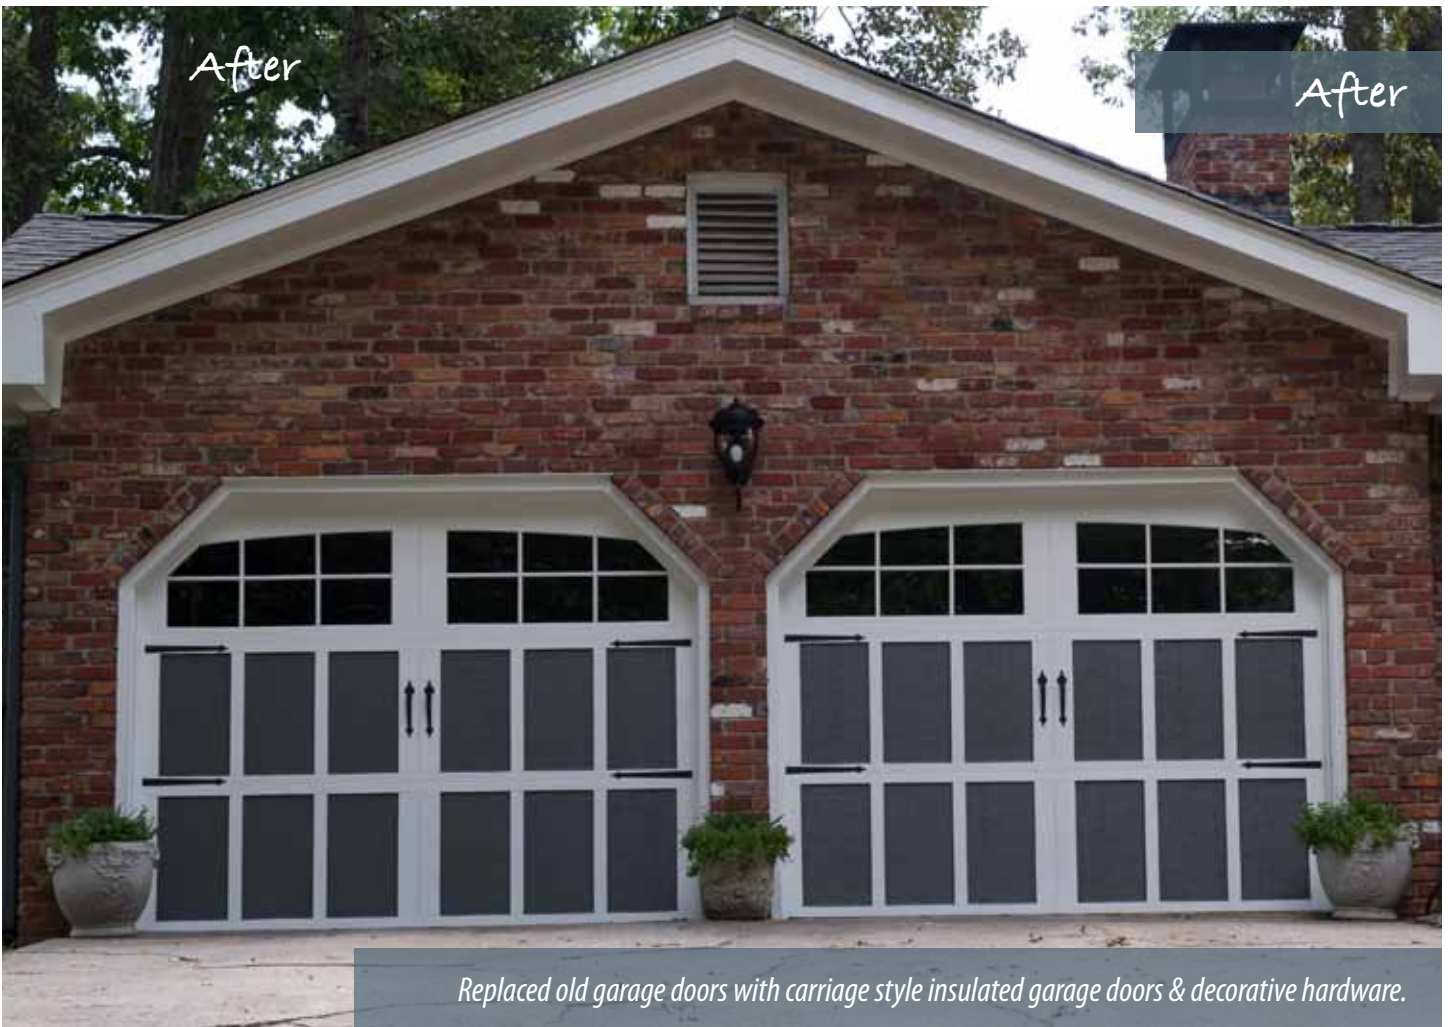
*Replaced old garage doors with carriage style insulated garage doors & decorative hardware.*

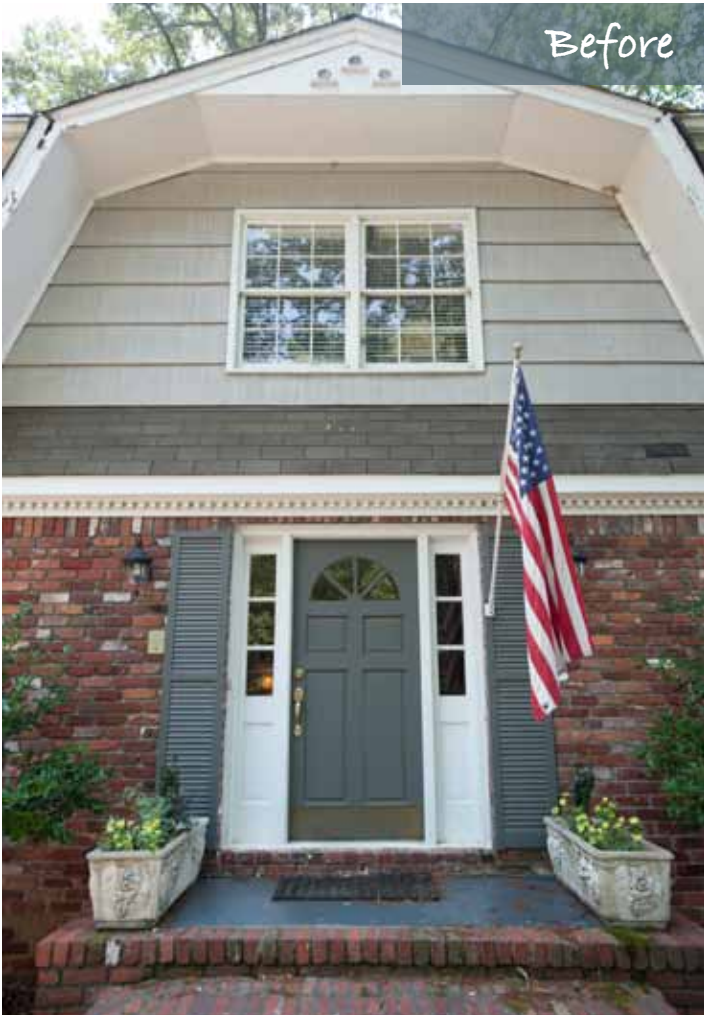
Before

*Old brick stoop and Gambrel roof overhang.*

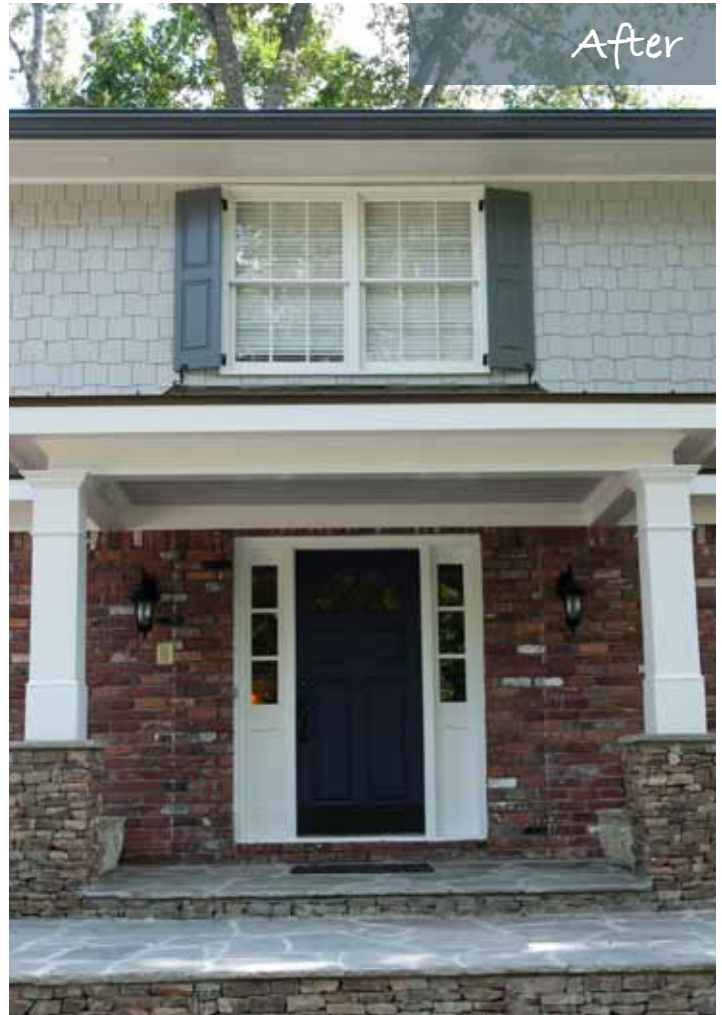
After

*Addition of portico with curved metal hip bay top, bead board ceiling and PVC columns with stacked stone pedestals.*

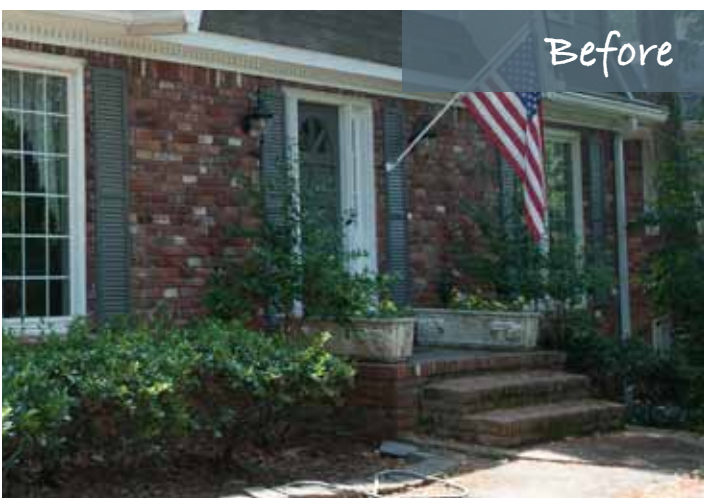
Before

*Old stoop with steps off front.*

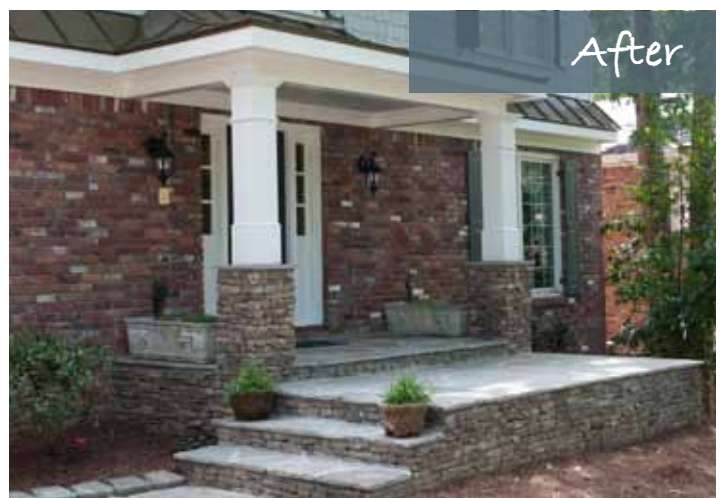
After

*New 6'x13' flagstone/stacked stone stoop, plus additional 6'x13' landing and 6'x18" steps on left side.*

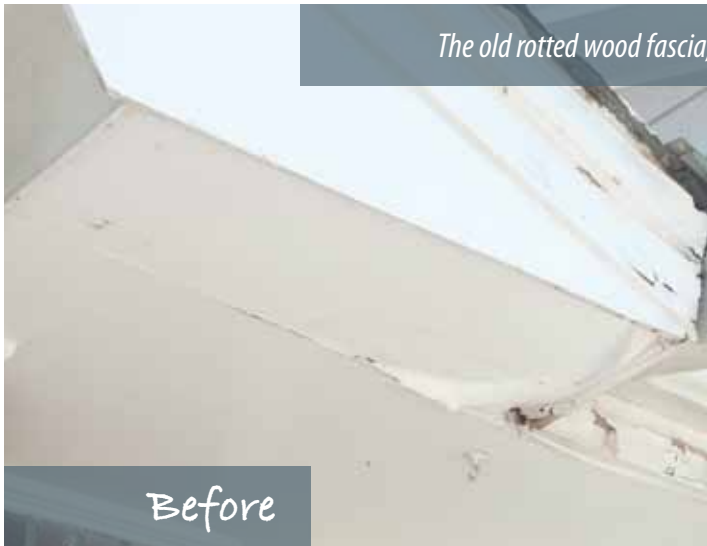
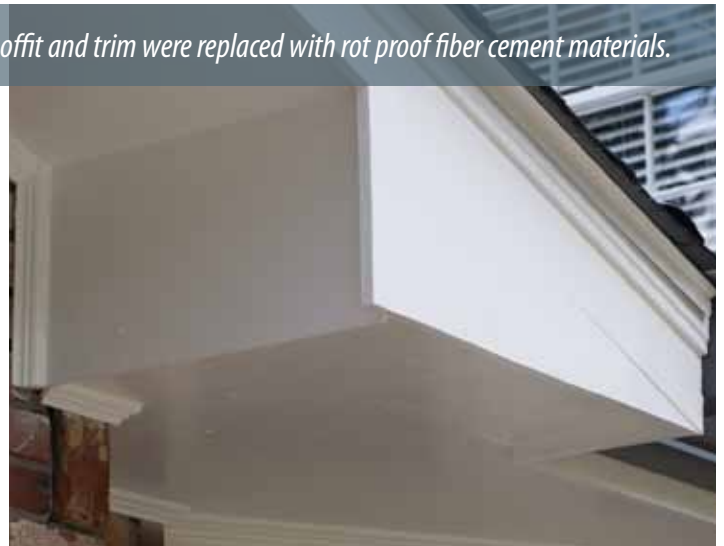
Before

*The old rotted wood fascia, soffit and trim were replaced with rot proof fiber cement materials.*

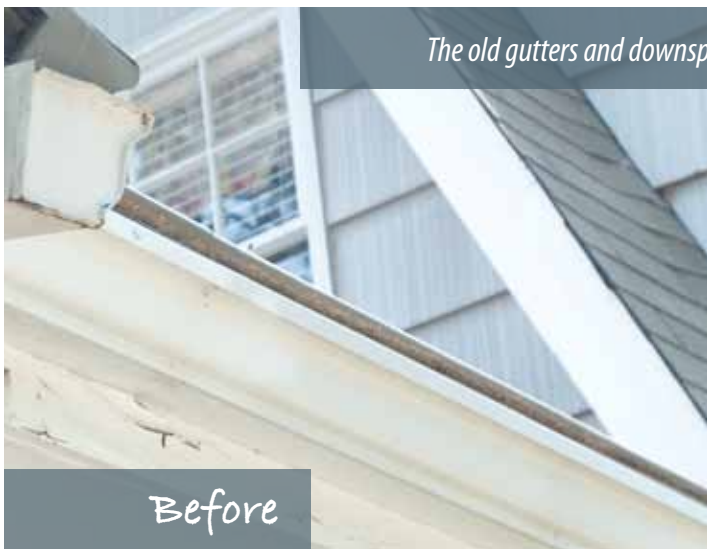
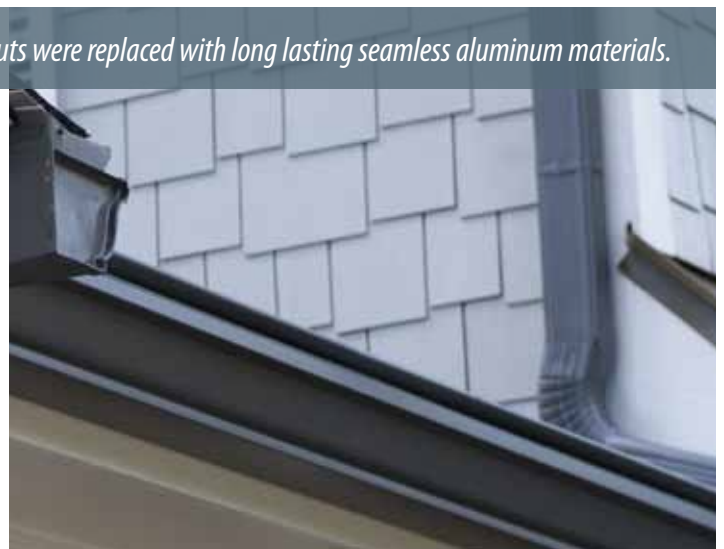
Before

*The old gutters and downspouts were replaced with long lasting seamless aluminum materials.*

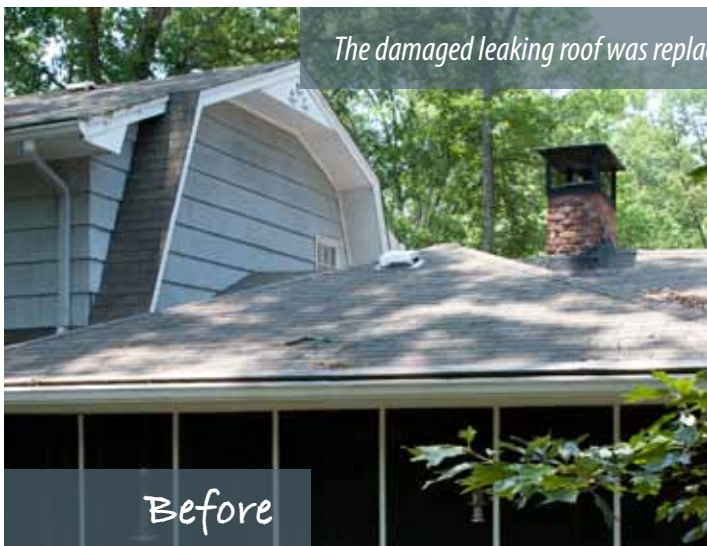
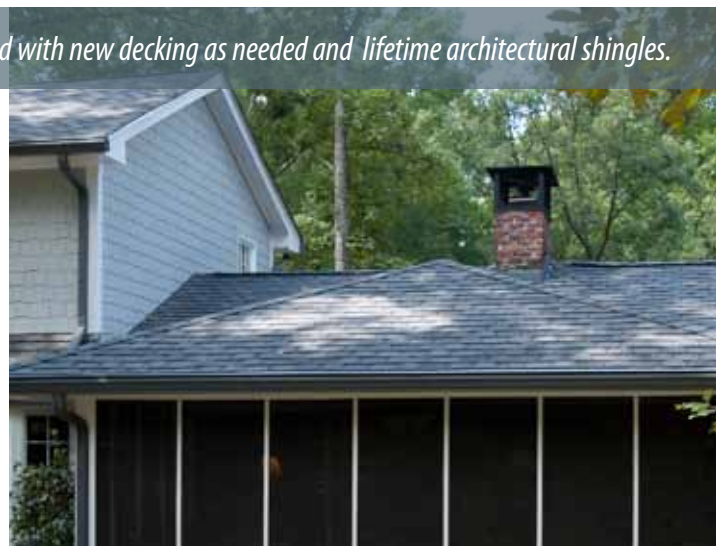
Before

*The damaged leaking roof was replaced with new decking as needed and lifetime architectural shingles.*

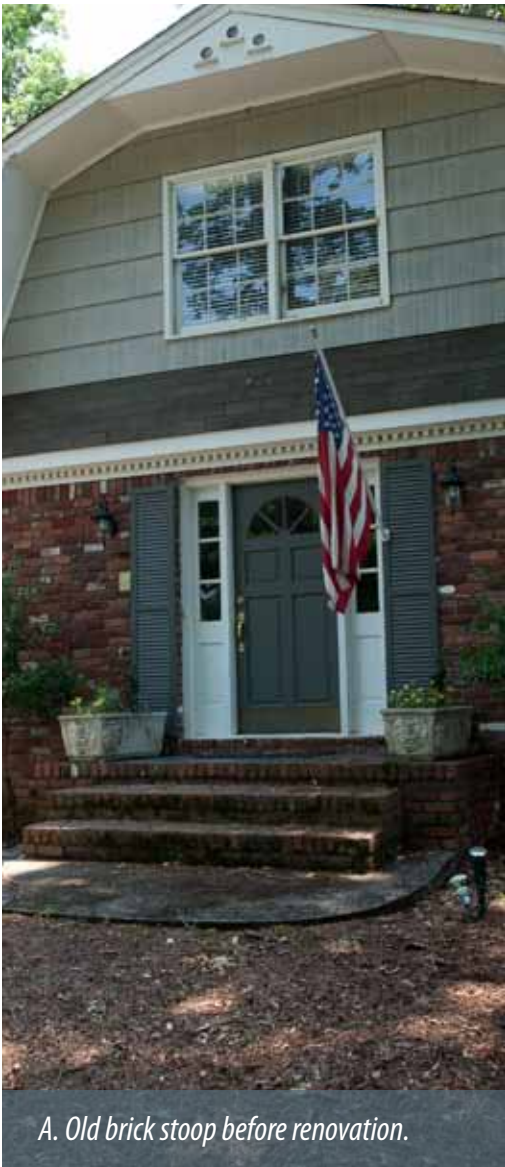
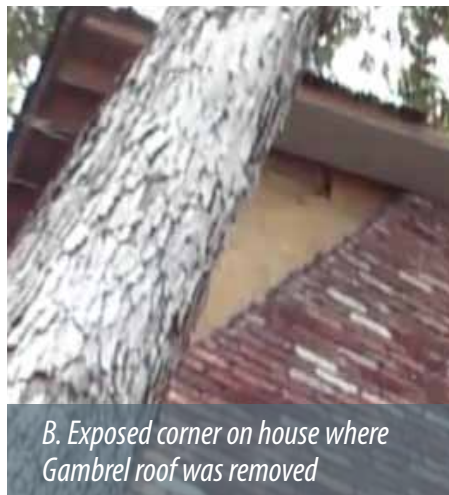
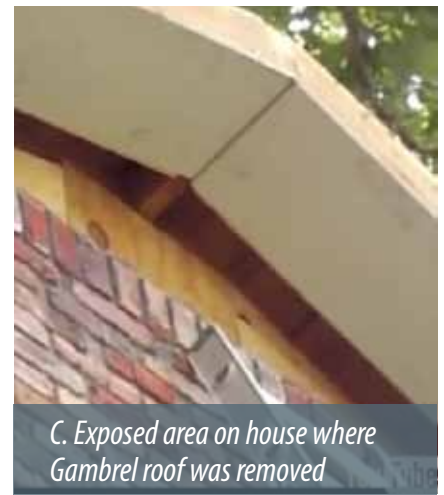
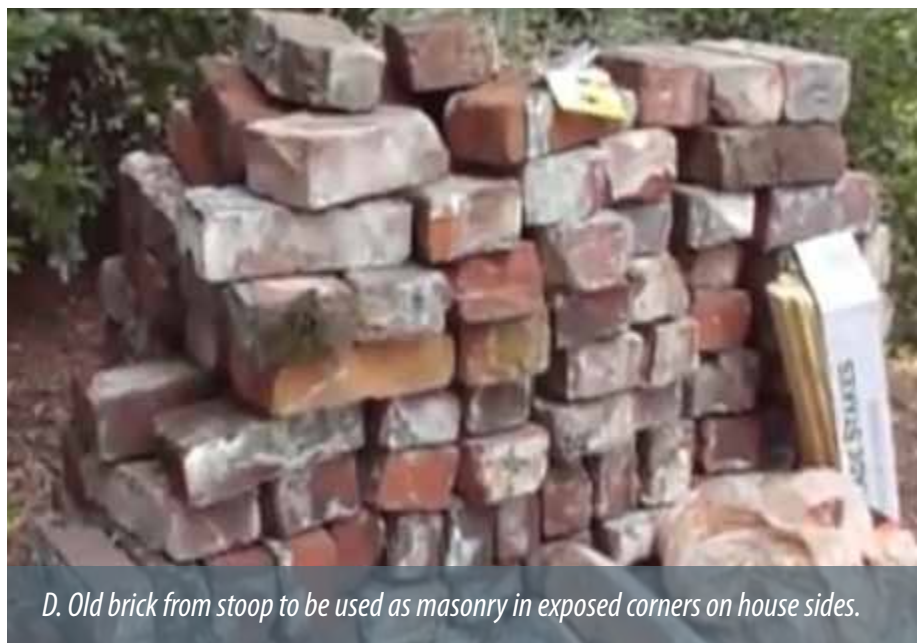
**SITUATION.** The sides of the home were originally constructed in all brick with the Gambrel roof angled down through the brick on both right and left corners. The homeowner wanted to remove the Gambrel roof entirely from the home's exterior...on the brick sides too.

**OBSTACLE.** Removing the Gambrel roof from the brick sides would leave a large exposed area in each corner of the house (see photos B and C). With the home being over 40 years old, it would be impossible to find an exact match for the brick.

**SOLUTION.** The brick from the old stoop (see photos A and D) was carefully chiseled out, one by one, so that it could be reused for masonry in the gaps created by the missing Gambrel roof in the corners on each side of the house.
